CASE STUDY

Ivey International Inc

PROPOSED USE

DESCRIPTION OF PROJECT

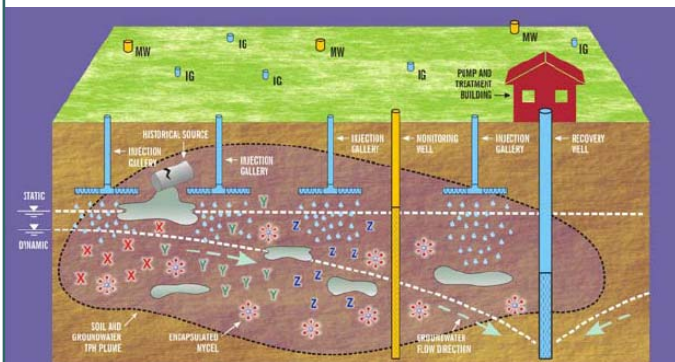
Injection Gallery Option

Prior to back-filling, a network of injection galleries as well a recovery well were installed. A pump and treat system was used to contain and recover the local contaminated ground water after each injection.

the classroom. The concrete floor was also removed and the excavation was completed to a depth of approximately two to four metres in some areas. Prior to backfilling, a network of injection galleries and a recovery well were installed.
